Rear Commodore's Comments

SV Independence

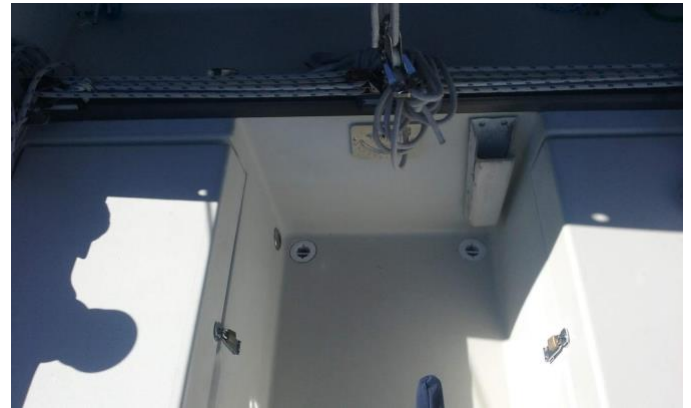
The design of my boat's cockpit is rather compact, with two seats (lazarette lids) running fore and aft on each side of the cockpit. Running athwartships immediately forward of the bench seats is what I call a "bridge deck". It is at the same level of the lazarette lids and is usually stepped onto as one passes in and out of the companion way. It is on this bridge deck (along its aft edge) that the traveler resides. The traveler is mounted with 12 bolts that penetrate the deck (6 per side), with washers and lock nuts accessible from below in the aft bilge.

Figure 1: Not a great photo but shown is how the traveler is mounted on the aft end of the bridge deck, forward of the lazarette seats.

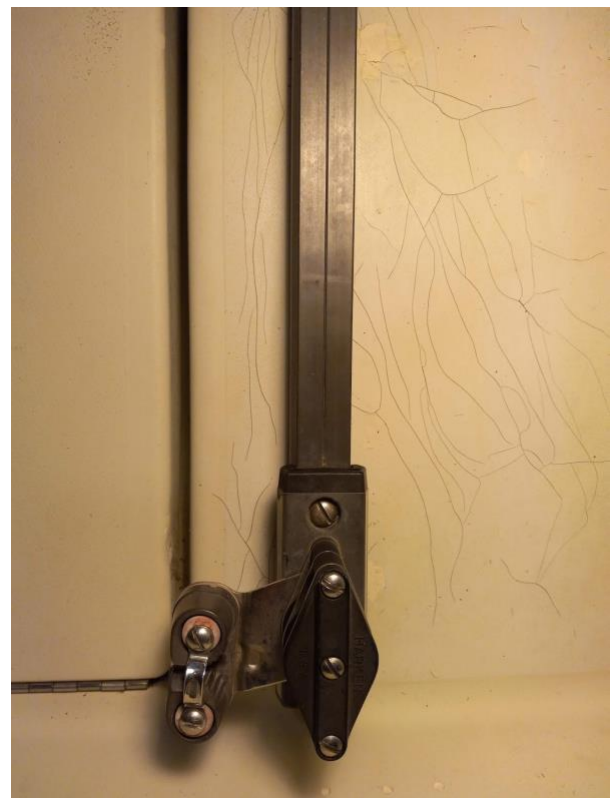
Figure 2: The "blemish" on the starboard side of the bridge deck. This was taken at the end of 2022 season but had not changed much since taking ownership in 2017.

The “blemish” I refer to were spider cracks on the bridge deck gel coat emanating from the traveler mounting area on both sides of the bridge deck, though less pronounced on the port side. The cracks were ugly, but I learned to live with them, especially since the task of repairing them was well beyond my expertise and comfort level. But with time and experience confidence builds and now, half a decade later, this was the off-season I was waiting for in order to repair it.

Around Thanksgiving I was ready to start. First up, remove the top skin. This was done with efficiency and very little mess using a vibrating bladed multi-tool. (Without a doubt this is my favorite new tool!) Once the skin was removed, the damage was clear. The end grain balsa core was very rotted and had lost any semblance of structural integrity. The lower skin appeared to be in pretty good shape except for where the fender washers on the traveler bolts had compressed the spongy core and deformed the lower fiberglass skin - dimpling it upward at several of the bolt holes.

Based on my analysis, it was this 1/8-inch thick lower skin of fiberglass (with obvious deformation at some of the bolt locations) that was providing most of the structure supporting the traveler. Had I suffered an accidental and violent gibe on a heavy wind day, the forces may have torn the traveler free, likely taking part of the deck with it! And not being confident that the lower skin was entirely sound, prudence dictated the addition of a more substantial backing plate to the underside of the area under repair.

Next up was adding the backing plates below. To add strength to the underside of the area being rebuilt I fabricated a 1/4-inch thick backing plate by sandwiching two 1/8-inch pieces of Luan ply with a layer of heavy fiberglass cloth between and a generous helping of thickened epoxy. Sealed along all surfaces, these new backing plates were then glassed into place against the lower skin (below the bolt holes) with thickened epoxy and a layer of 1708 fiberglass cloth. This was then followed up with another layer of 1708 glass across the exposed (lower) surface of the backing plates and tabbed onto adjacent structural components.

With these and other incidentals behind me, it was time to tackle the main event: replacing the core and building a new glass skin for the bridge deck. Essentially, it involved using laminating polyester resin to lay up fiberglass mat, new end grain balsa core, several layers of fiberglass (1708, four layers CSM - chopped strand mat-veil) and then PVA to seal it for a full cure. Prior to working and throughout the lay up the workspace maintained a temperature of about 75°F and for the overnight incandescent lights were all that was needed to warm the surfaces for effective curing. As for me, after about four hours of wearing a facial respirator, I was happy to get out, breathe some fresh air and let it cure. Which it did as planned. A bit of sanding and fairing came next and then gel coating.

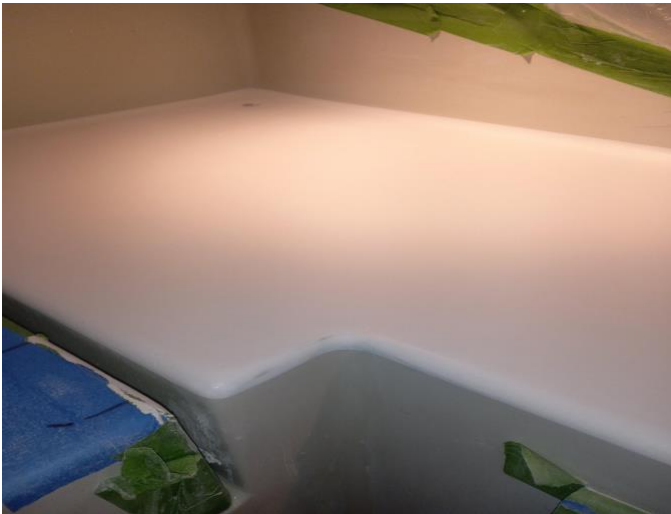
Figure 3: Port side after gel coat cure but before sanding.

DIY job, it would still look better than the ugly cracks that were there before. The boat's 42 years old, after all! So headlong I plunged into the great unknown... Using brushes, I commenced to laminate layers of gel coat one on top of the next. The final layer (fifth or sixth) was sealed with PVA and kept warm with lights. After walking away, I was again delighted to remove the respirator and get some fresh air.

Can you imagine the trepidation I felt upon my return a day or two later to see the outcome? Did it fully cure? Was it warm enough with the lights? What would I find? I am happy to report it was cured and looked pretty darn good. Sure, there were some brush marks, but I had put the last layer on heavy and after wet sanding from 220 to 1500 grit the effect was mostly ameliorated. It looks pretty good; definitely not professional, but much better than before and if it looks worse in the sunlight, I wouldn't hesitate to apply gel coat again.

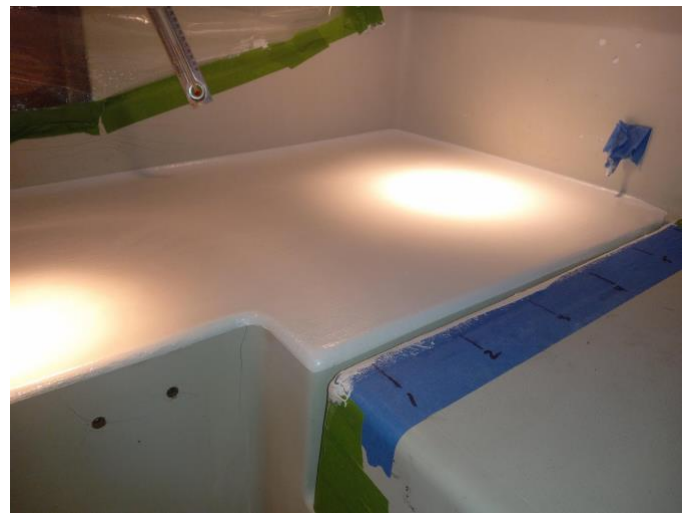
Figure 4: Starboard side after gel coat cure but before sanding.

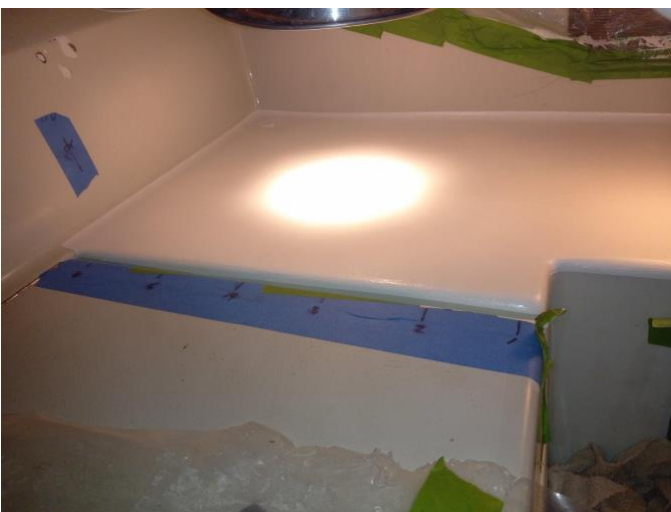
Figure 5: Port side after wet sanding.

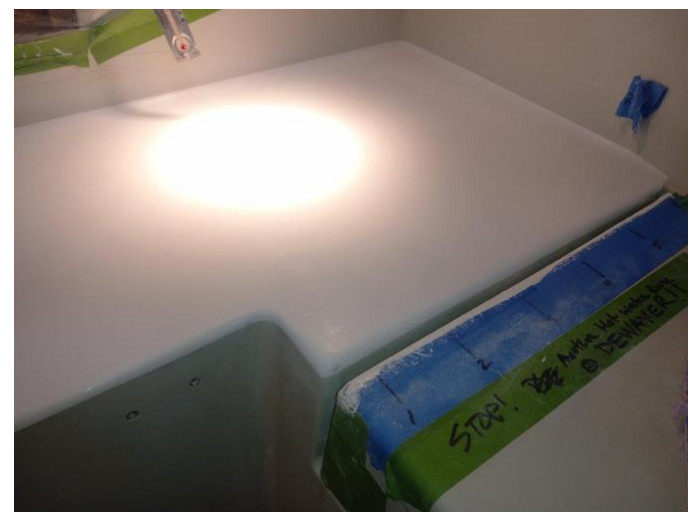
Figure 6: Starboard side after wet sanding.
